Devil's Slide/Hwy 1 Storm Repair

Daily Updates from Bijan Sartipi

Daily Update
July 12

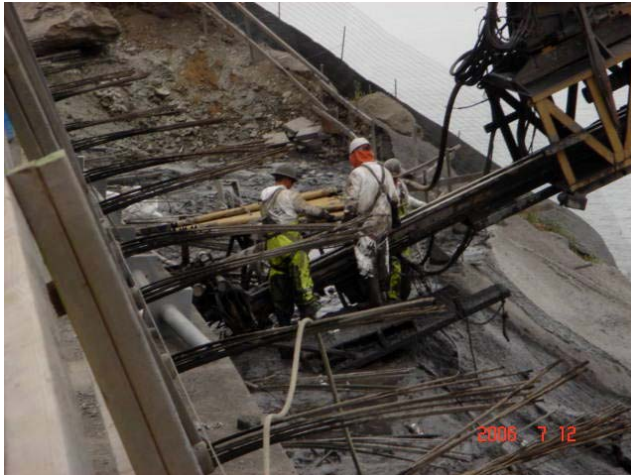
Drilling for the last tie back at level B

- Level 'B' (lower level ocean side) – Drilling for tie backs continued using the reach over rig. 57 of 58 tie backs now installed. Tie back stressing also continued.

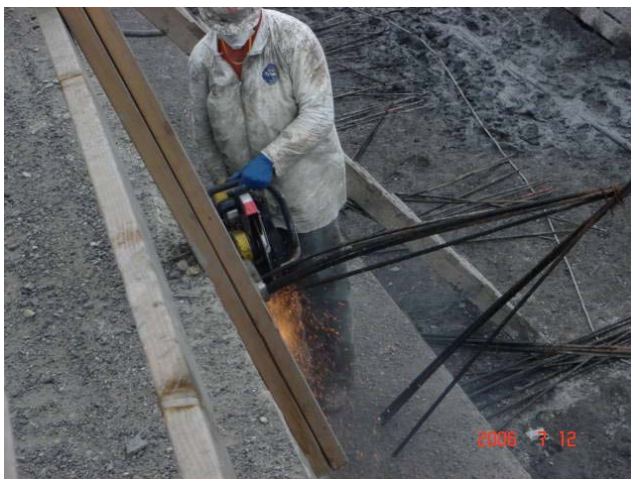
Cutting off excess after cables are tightened – level A

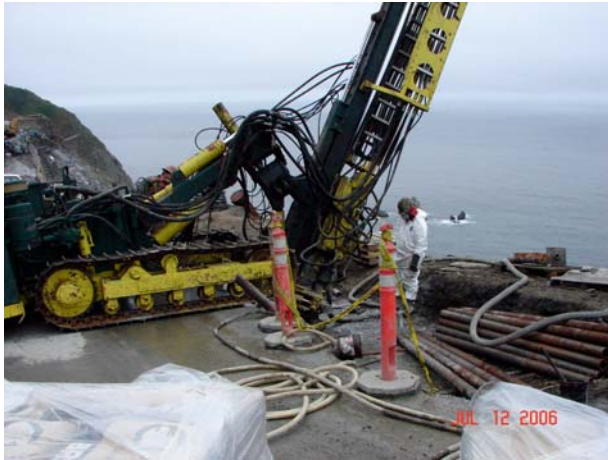
Drilling for micropiles

- Drilling and driving steel piles continued today. 44 of 99 now installed.

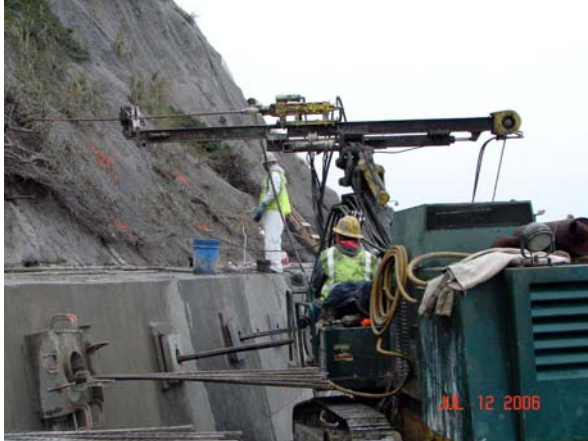
Drilling for rock bolts

- Drilling continued today to install 50 rock bolts above the level D bracing wall. These 15 feet long bolts will knit fractured rocks together reducing the risk rocks falls.
